# Galway County Council N6 Galway City Ring Road Karst Survey Report

GCOB-4-03-0-6.2.8\_010

Issue 3 | 26 July 2018

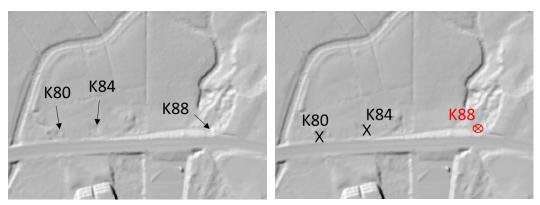
**Figure 2a** shows the lidar image of three potential enclosed depression identified from the desk study. During the site visit K88 was confirmed to be an enclosed depression, however, onsite inspection K80 and K84 were found to be mounds and therefore classified as not karst (Figure **2b**).

**Figure 2a** (left) lidar image showing three potential enclosed depressions identified from the desk study, **2b** (right) the field survey confirmed enclosed depression K88 (red circle) but also proved that K80 and K84 (black crosses) were not karst.

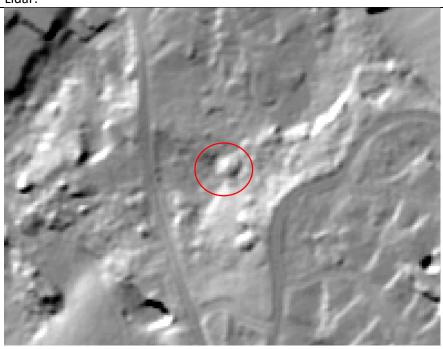
Feature ID	K44
Feature type	Enclosed depression
Coordinates	529836, 727798
Source	Lidar:

Field survey date	16/10/2014
Field survey status	Confirmed
Water present	No
Additional	Small depression with rock exposed
Information	Approx. 2 m diameter and 1 m depth

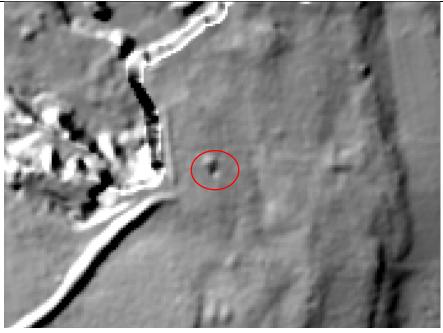
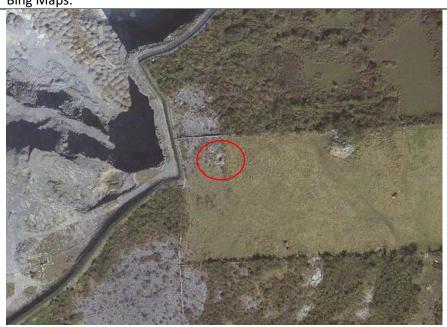
Feature ID	K67
Feature type	Enclosed Depression
Coordinates	530629, 728329
Source	Lidar:
	A STATE OF THE PARTY OF THE PAR

Field survey date	21/10/2014
Field survey status	Confirmed
Water present	No
Additional	Numerous boulders in depression
Information	Approx. 20 x 10m diameter and depth of 2m

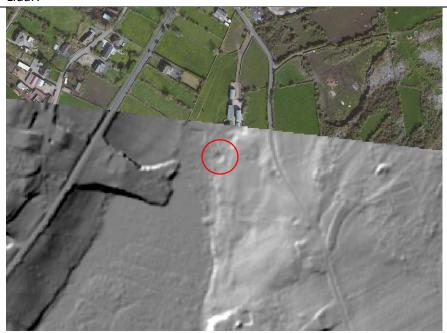
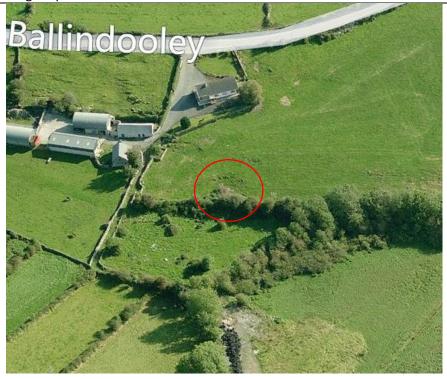
Feature ID	K94	
Feature type	Enclosed depression	
Coordinates	531814, 729415	
Source	Lidar:

Field survey date	21/10/2014	
Field survey status	Confirmed	
Water present	No	
Additional	Approx. 15m diameter	
Information	Access inhibited due to cattle in field

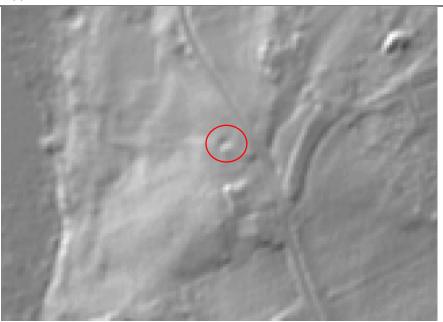
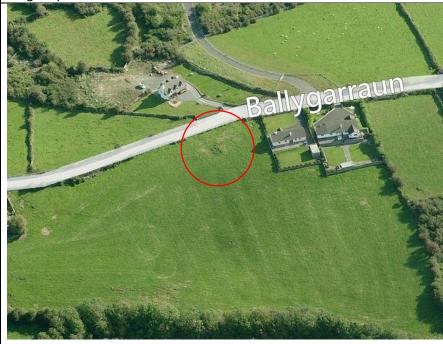
Feature ID	K98	
Feature type	Enclosed Depression	
Coordinates	531924, 729321	
Source	Lidar:

Field survey date	21/10/2014	
Field survey status	Confirmed	
Water present	No	
Additional	Approx. 3m diameter depression	
Information

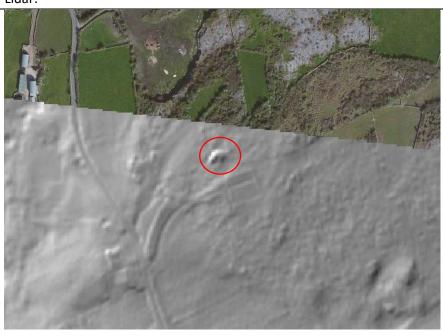
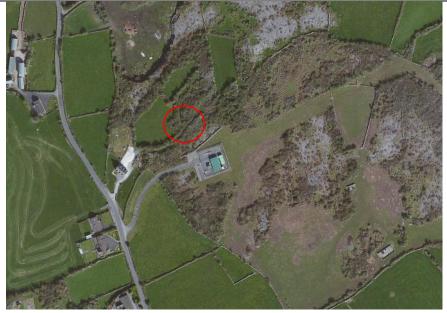
Feature ID	K100
Feature type	Enclosed depression
Coordinates	532049, 729396
Source	Lidar:

Field survey date	21/10/2014
Field survey status	Confirmation/identification problem
Water present	n/a
Additional	Feature not found. Access hindered due to dense hazel scrub
Information	
Site photos	Not available

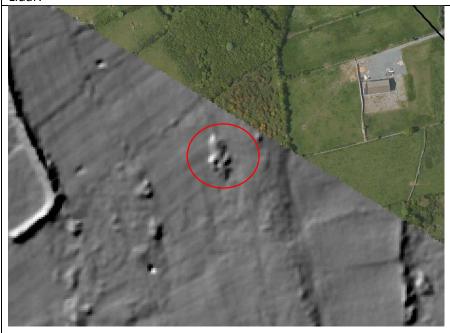
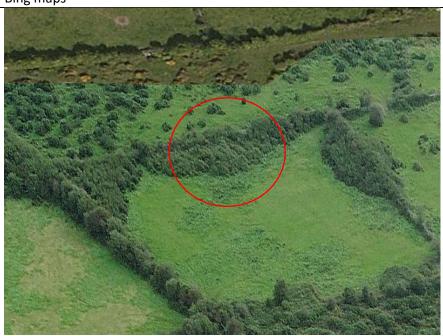
Feature ID	K174
Feature type	Enclosed depression
Coordinates	534854, 728406
Source	Lidar:

Field survey date	22/10/2014
Field survey status	Confirmation/identification problem
Water present	No
Additional	Appears to be dip in topography but cannot gain access due to dense
Information	vegetation
Site photos	Not available
