A Survey of Selected Rivers for
the Galway City Transport
Project with Potential for Margaritifera
(Moorkens, 2014a)

A SURVEY OF SELECTED RIVERS FOR THE GALWAY CITY TRANSPORT PROJECT WITH POTENTIAL FOR *MARGARITIFERA*

September 2014

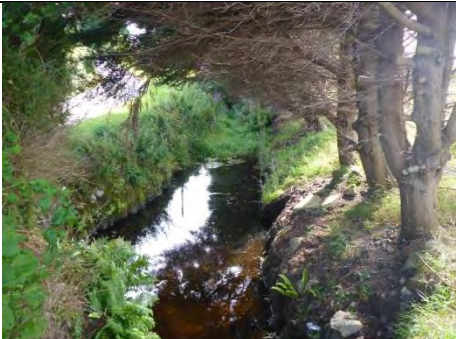
Site M	Larger water body but slow flowing and highly silted, narrow and tunnelled upstream. No <i>Margaritifera</i> habitat	
Barna stream upper branch		
M24369 26282

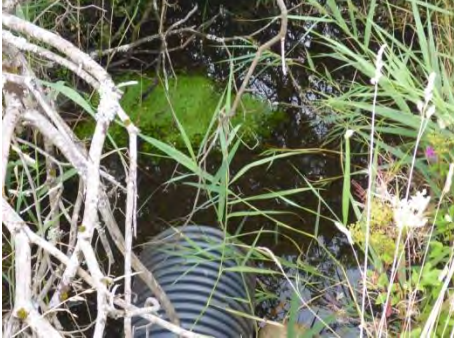
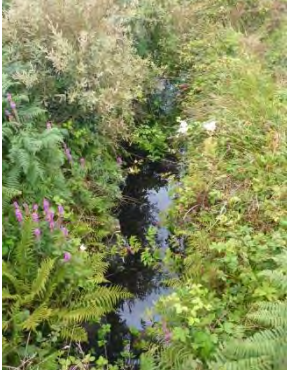
Site O	Tunnelled, overgrown, very little flow, <i>Callitriche</i> , sandbags, culverted pipe. Narrowed downstream, water with grey tinge	
Barna Stream main channel		
M25346 26206

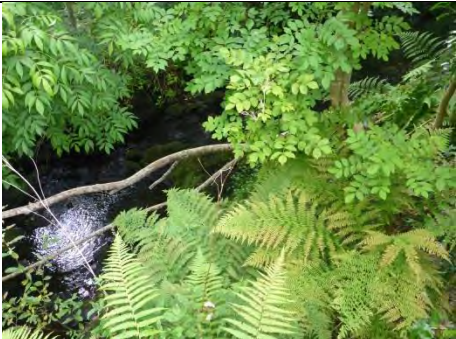
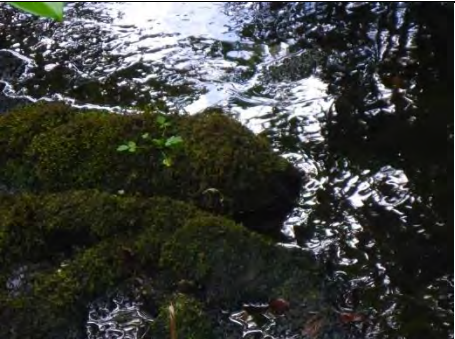
Site P	Good flow with mossy rocks in stream, good boulder and gravel mixed substrate. Tree-lined banks, but lots of new housing estates nearby. Rather shallow, mostly less than 20cm deep but with flow where gradient is good. Some potential but no mussels found.		
Barna Stream main channel			
M24644 23946
