Galway City Transport Project – Habitat mapping and assessment of a section of Lough Corrib cSAC and surrounding areas (Barron et al., 2017)

N6 Galway City Ring Road

HABITAT MAPPING AND ASSESSMENT
OF A SECTION OF LOUGH CORRIB
cSAC AND SURROUNDING AREAS

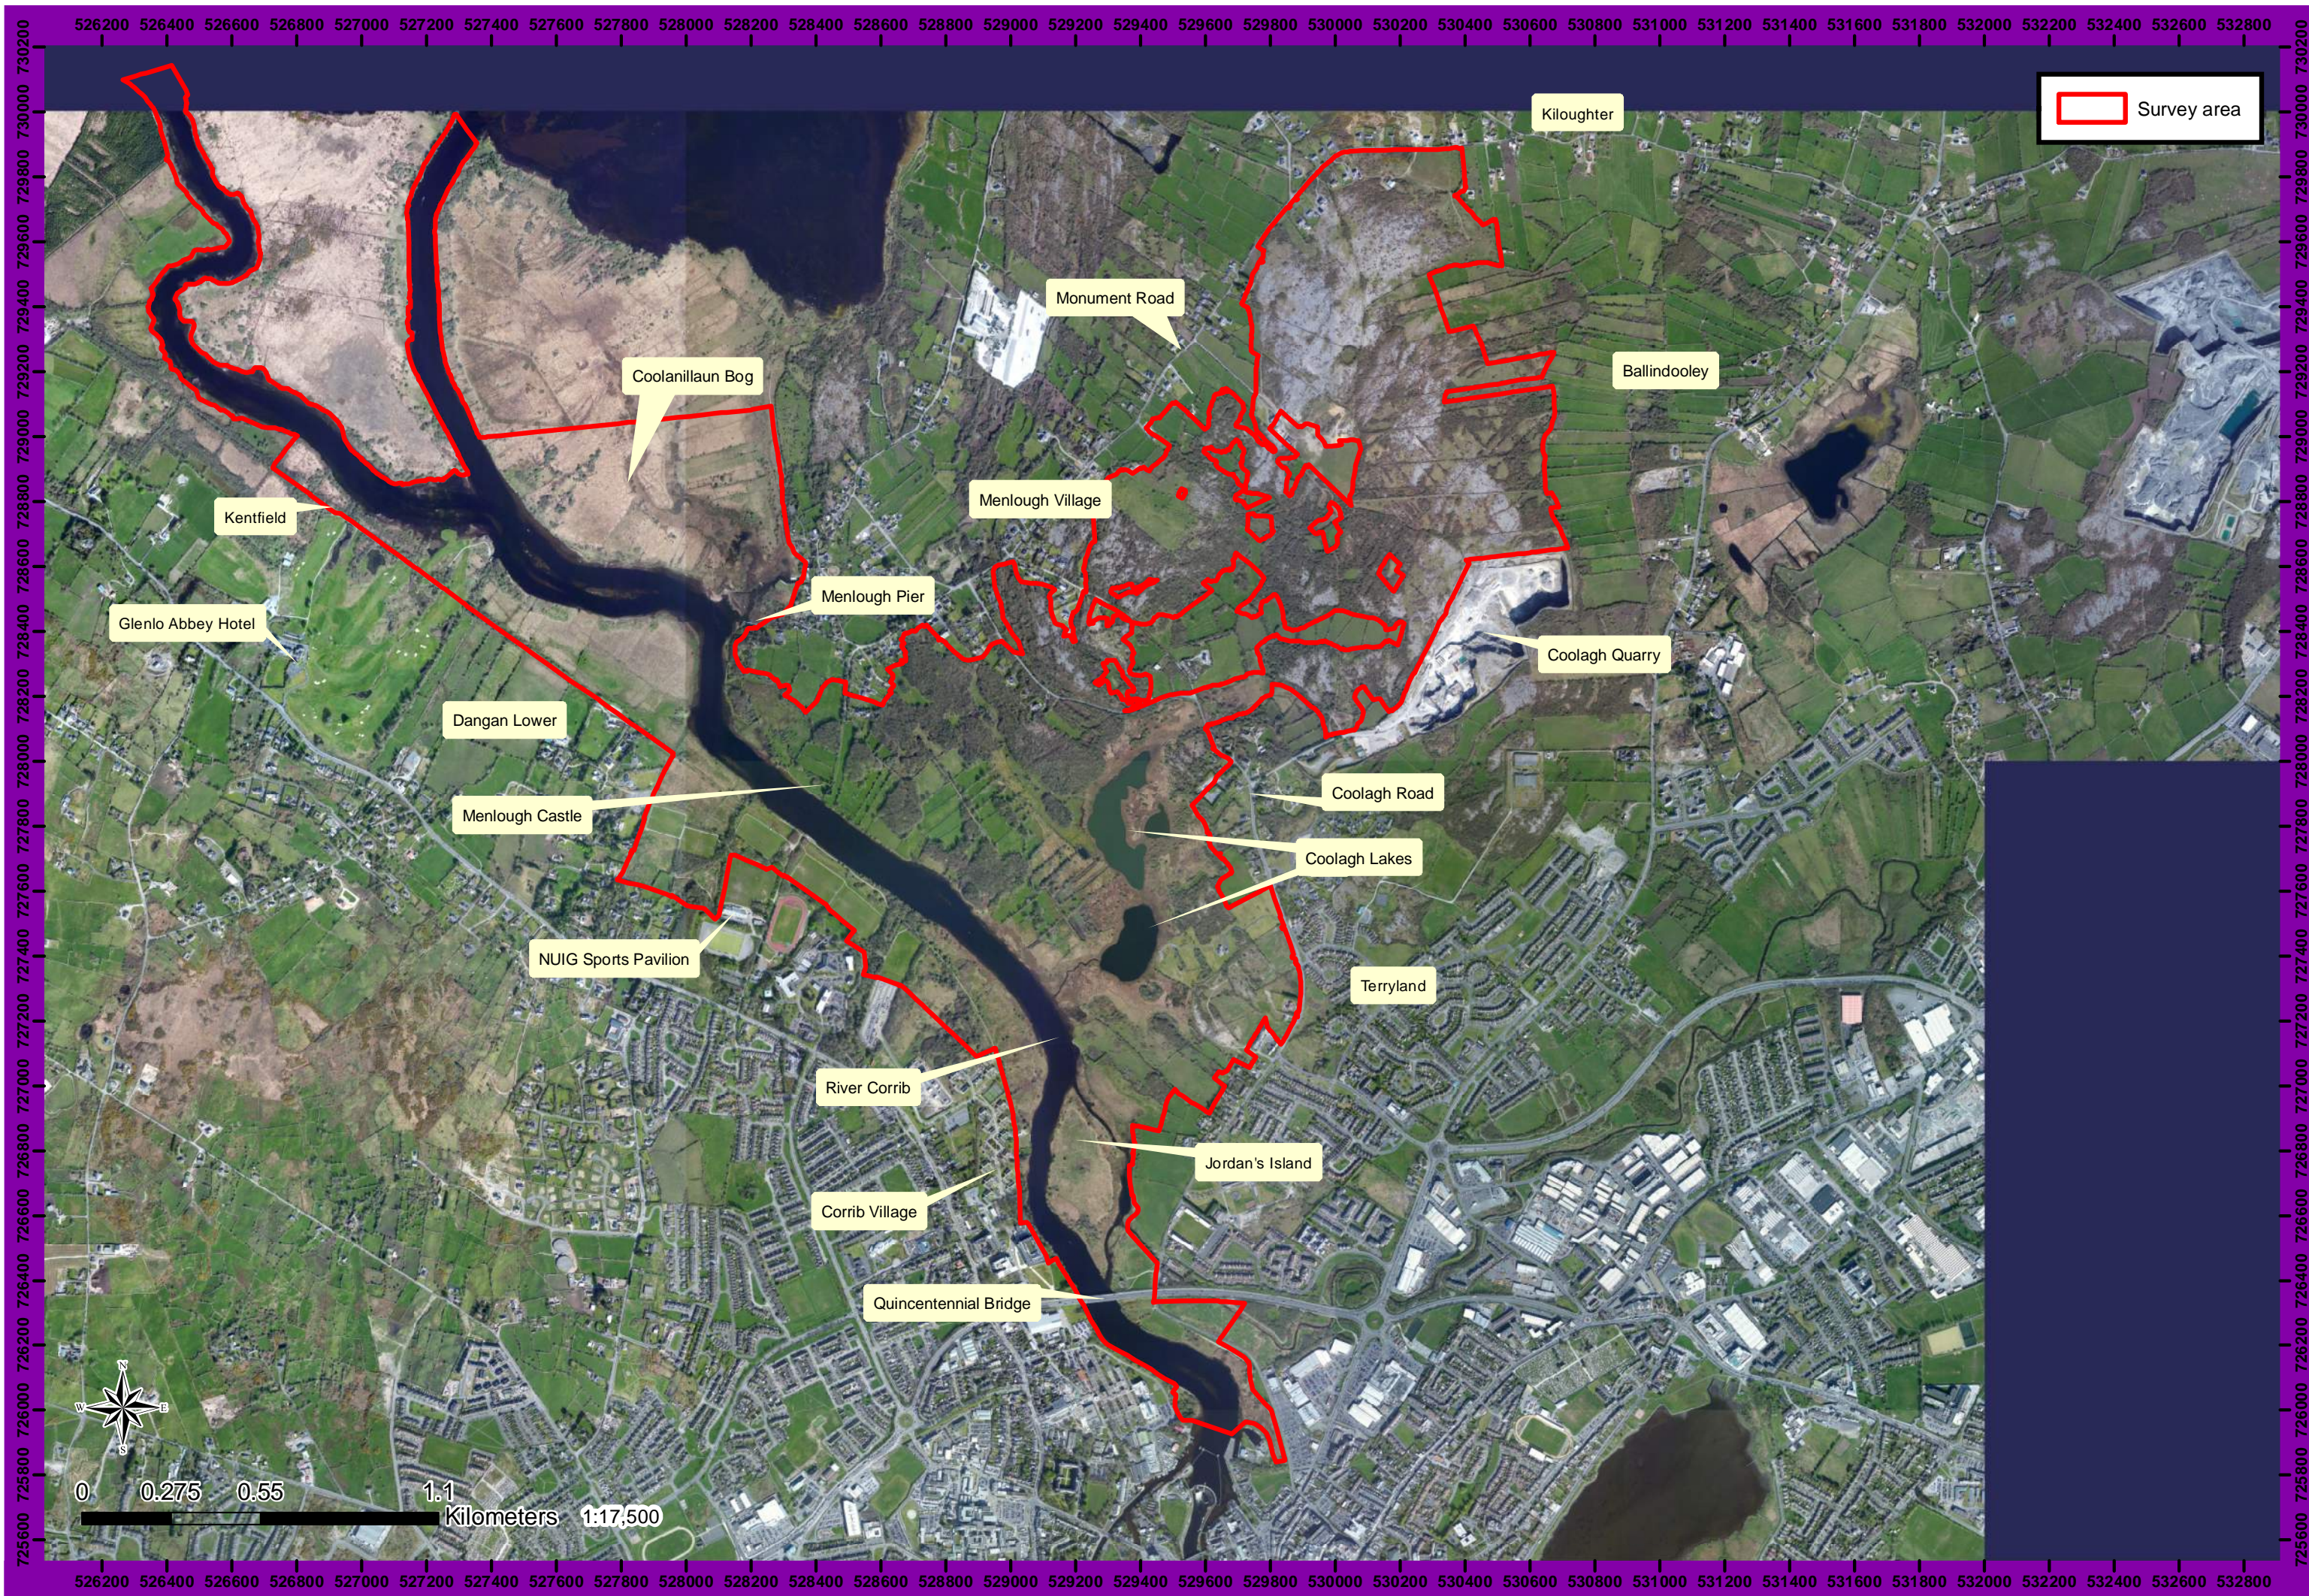
Figure 1. Survey area

The extent of the survey area, which covers 478.2 ha, is shown in Figure 1. Excluding the area covered by rivers and lakes, the area surveyed and mapped for this project in 2013 and 2014 is 388.8 ha. The habitat maps presented in Figures 2a-d were created in ArcMap and show the habitats according to the Fossitt (2000) classification scheme. A total of 41 Fossitt (2000) habitats were recorded during the survey. It should be noted that, where a mosaic of habitats was recorded, only the primary habitat (i.e., the one with the highest percentage cover) is represented. A summary of the area of the Fossitt habitats surveyed is presented in Table 4, and further data are available in the associated GIS shapefile.
