# Galway County Council N6 Galway City Ring Road Karst Survey Report

GCOB-4-03-0-6.2.8\_010

Issue 3 | 26 July 2018

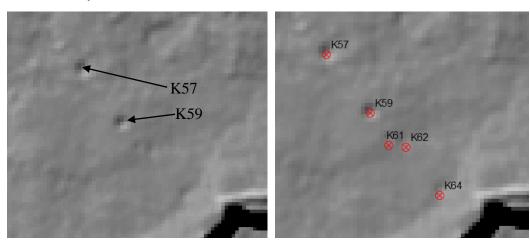
**Figure 1a** (left) lidar image showing two potential enclosed depressions identified from the desk study, **2b** (right) karst features confirmed during field survey

Potential features were identified during the desk study and then investigated in the field. As an example, **Figure 1a** presents the lidar image showing two clear circular shapes interpreted as likely karst landforms but also shows multiple surrounding features that are less clear. The potential features (K57 and K59) were visited and confirmed as enclosed depressions during the field survey. Survey of the surrounding features also confirmed three further enclosed depressions (K61, K62 and K64) as shown in **Figure 1b**.

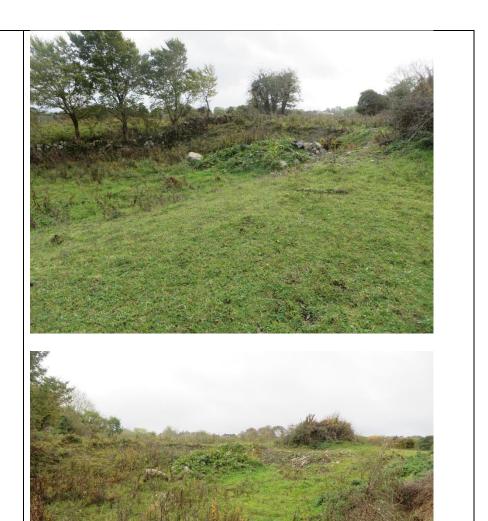
Feature ID	K11	
	Enclosed depression	
Source	Enclosed depression 527396, 728307 Lidar:  Bing Maps:	
	Other sources: aerial photography 20/10/2014	
,	Confirmed	
Water present	No	
	15m diameter enclosed depression.	
	15m diameter enclosed depression.

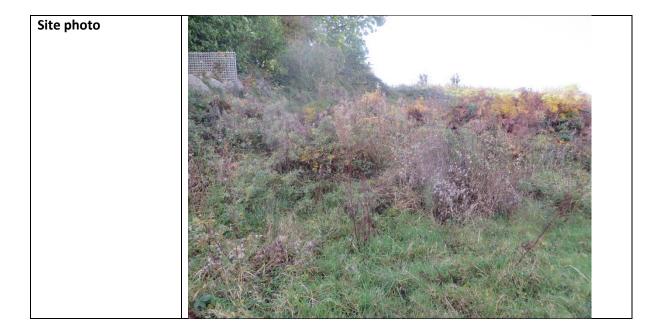
Feature ID	K12	
Feature type	Enclosed depression	
Coordinates		
	Enclosed depression 527555, 728068 Lidar:  Bing Maps:	
	Other sources: aerial photography	
Field survey date	21/10/2014	
Field survey status	Confirmed	
Water present	No	
Additional	20m diameter enclosed depression with gently slopped sides.	
Information

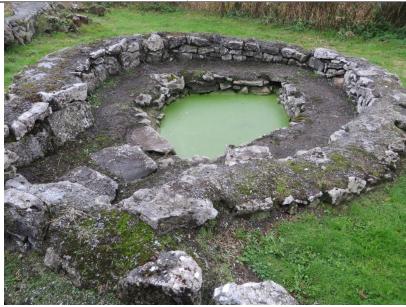
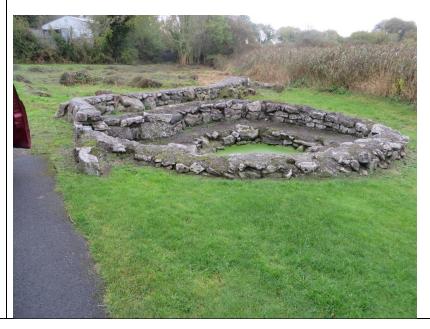
Feature ID	K17	
Feature type	Spring	
Coordinates	528345, 728630	
Source	Field Survey	
Field survey date	17/10/2014	11/11/2014
Field survey status	Confirmed	Confirmed
Water present	Yes	Yes
	Electrical conductivity: 520 uS/cm	Electrical conductivity: 622 uS/cm
	Temperature: 13.8 °C	Temperature: 12 °C
	pH: 7.83	pH: 6.87
Water elevation	n/a	6.12 mAOD
Additional	Constructed pond (2 m diameter) covered in algae surrounded by	
Information	constructed stone wall beside path.	
Site photos		Maria Maria Maria

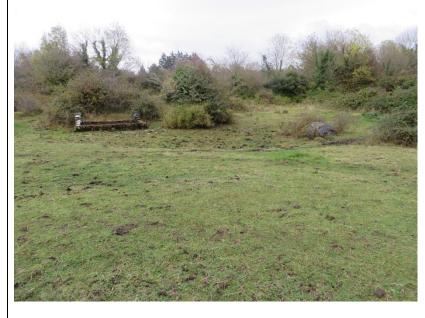
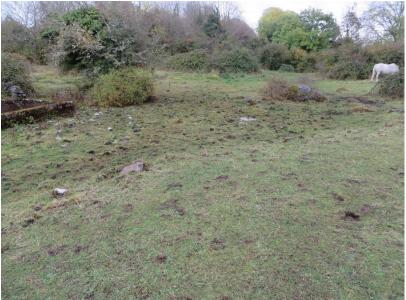
Feature ID	K18	
Feature type	Enclosed depression	
Coordinates	528356, 728948	
Source	Lidar:	
Journe	Bing Maps:	
	Other sources: aerial photography	
Field survey date	17/10/2014	
Field survey status	Confirmed	
Water present	Yes	
	Electrical conductivity: 350 uS/cm Temperature: 14.2 °C pH: 8.72	
Additional	Water logged depression in field.	
Information	1.3.2

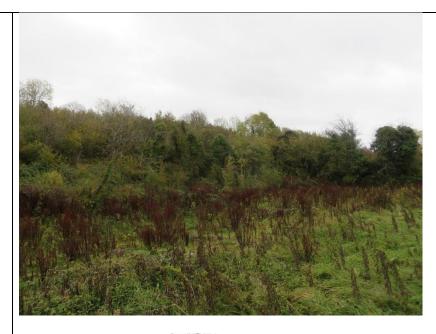
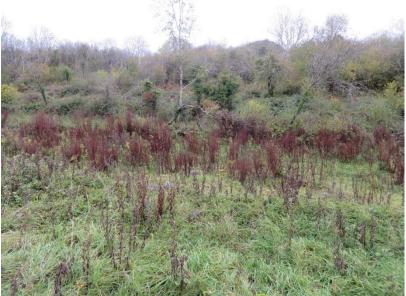
Field survey date	17/10/2014
Field survey status	Confirmed
Water present	No
Additional Information	Turlough is divided in two parallel sections with relatively well defined edges. The elevation of the eastern section is lower than the western section. A potential plug hole evident in the upper western section

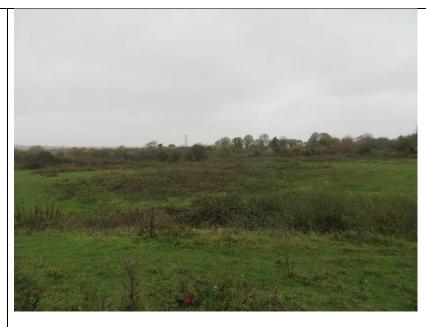
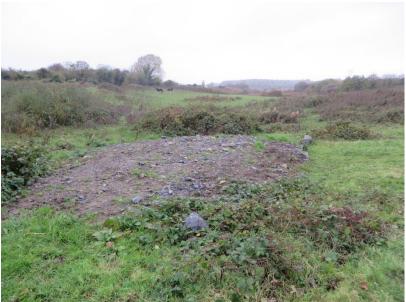
Feature ID	K39
Feature type	Enclosed depression
Coordinates	529566, 726981
Source	Lidar:
	Bing Maps:
Field survey date	20/10/2014
Field survey status	Confirmed
Water present	No
Additional Information	30 m diameter enclosed depression. However this feature is questionable as there may be disposal of material to the east of the depression.

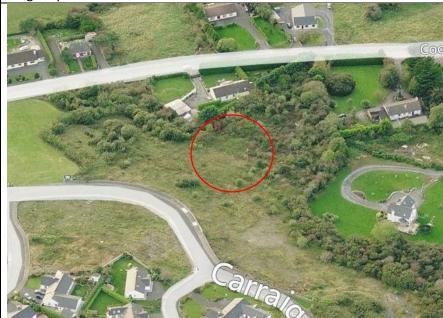
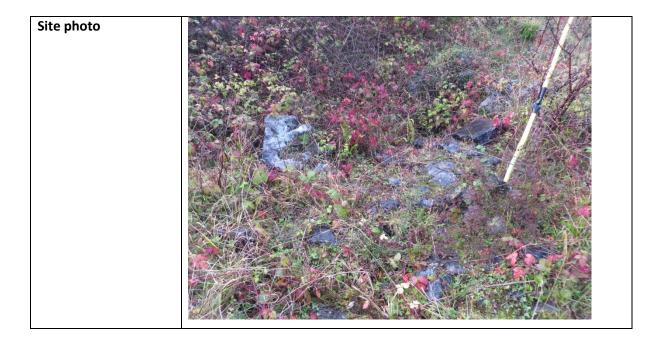
Field survey date	16/10/2014
Field survey status	Confirmed
Water present	No
Additional	Small depression with rock exposed
Information	Approx. 2 m diameter and 1 m depth

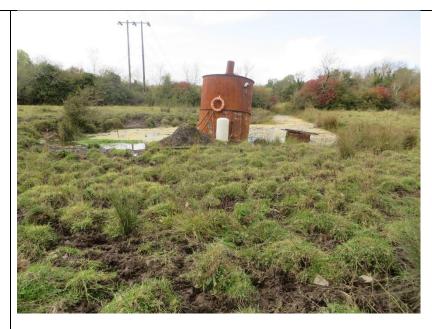
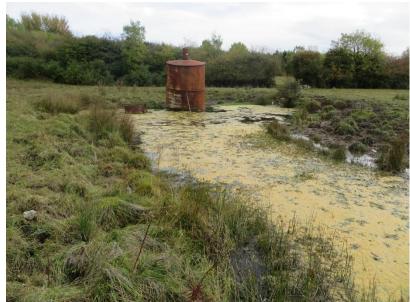
Feature ID	K45
Feature type	Spring
Coordinates	529900, 728162
Source	Lidar and OSI water line:
	Bing Maps:
Field survey date	16/10/2014
Field survey status	Confirmed
Water present	Yes Electrical conductivity: 680 uS/cm Temperature: 15.1 °C pH: 7.28
Additional	
Information

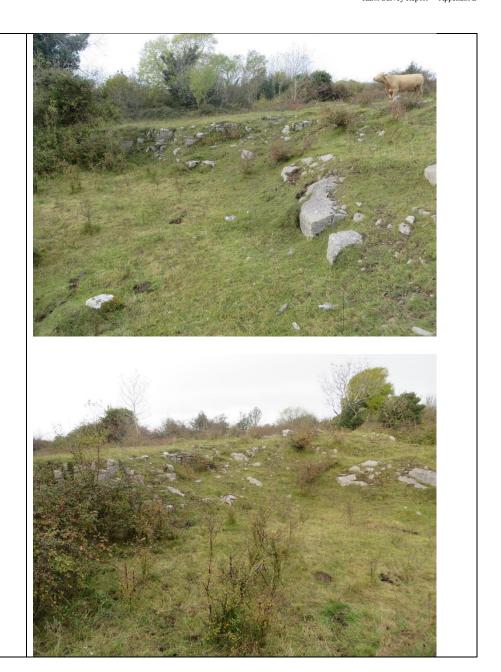
Feature ID	К49
Feature type	Enclosed depression
Coordinates	530028, 728162
Source	Lidar:
	Bing Maps:
Field survey date	16/10/2014
Field survey status	Confirmed
Water present	No
Additional	Exposed rock at northern side and gentle slope on Southern side
Information	Approx. 20 m diameter 2 m depth

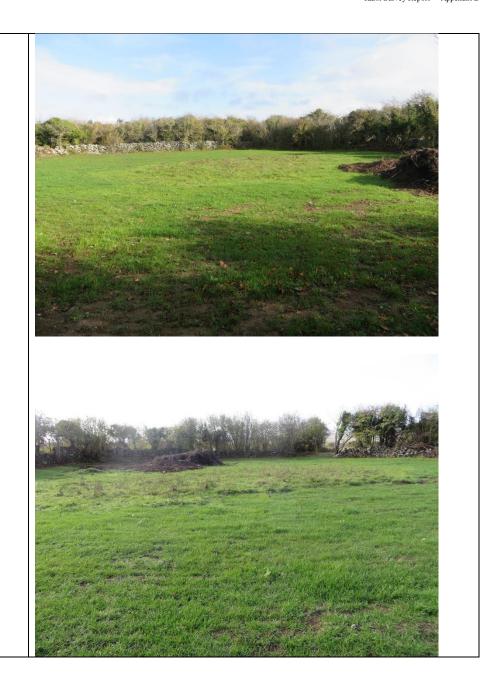
Feature ID	K50
Feature type	Enclosed depression
Coordinates	530041, 729241
Source	Lidar:
	Bing Maps:
Field survey date	16/10/2014
Field survey status	Confirmed
Water present	No
Additional	Slight enclosed depression which may be filled in
Information	Singific enclosed depression which may be filled in
miorination

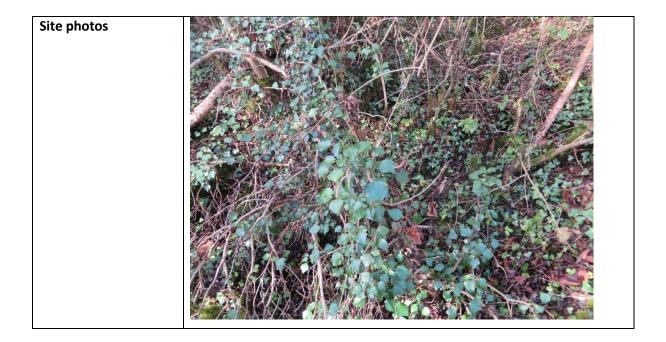
Feature ID	K51
Feature type	Enclosed depression
Coordinates	530084, 728466
Source	Lidar:
	Bing Maps:
Field survey date	16/10/2014
Field survey status	Confirmed
Water present	No
Additional	Very small enclosed depression plug hole not obvious but probably due
Information	to covering of moss

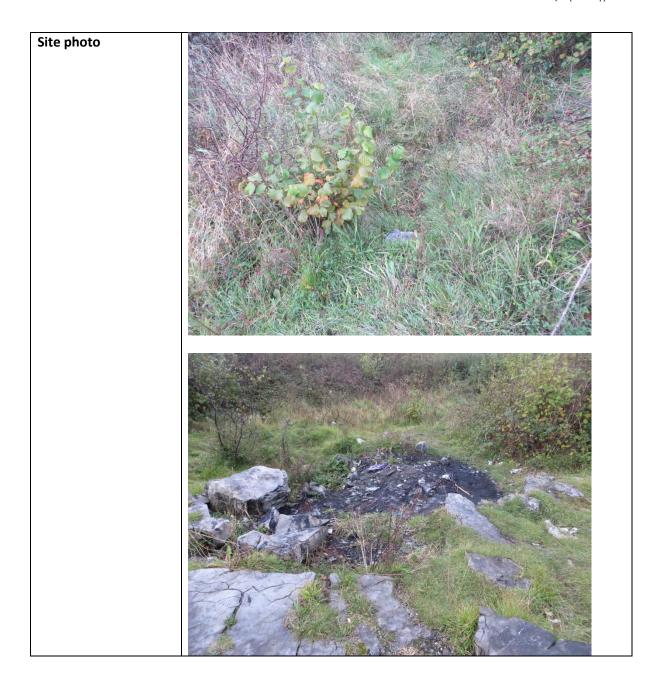
Feature ID	K65
Feature type	Enclosed Depression
Coordinates	530452, 727738
Source	Lidar:
	Bing Maps:
Field survey date	16/10/2014
Field survey status	Confirmed
Water present	No
Additional	2 depressions 3 m diameter and 1 m diameter less than 0.5 m depth.
Information	Larger depression is filled with a fire pit

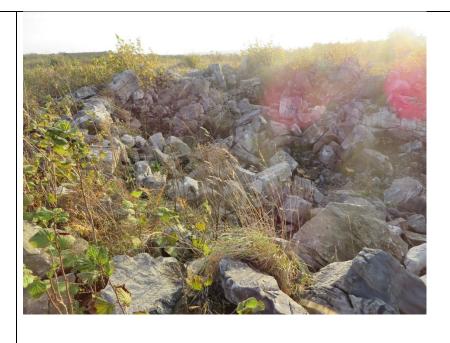
Field survey date	21/10/2014
Field survey status	Confirmed
Water present	No
Additional	Numerous boulders in depression
Information	Approx. 20 x 10m diameter and depth of 2m

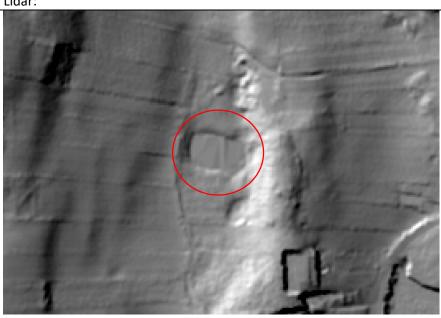
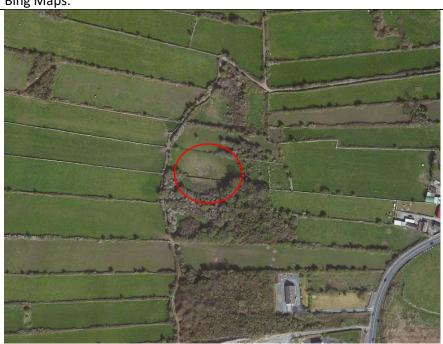
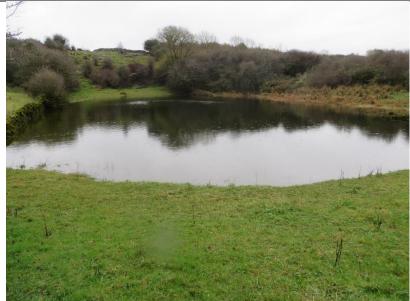
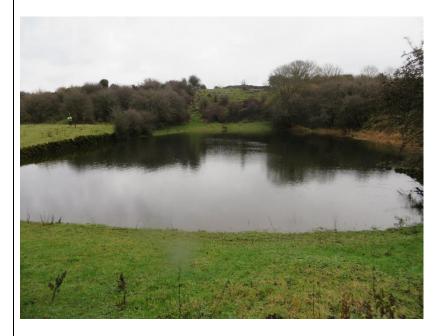
Field survey date	12/11/2014
Field survey status	Confirmed
Water present	Yes
	Electrical conductivity: 513 uS/cm
	Temperature: 9.2 °C
	pH: 7.37
Water elevation	14.13 mAOD

Additional Turlough visited while in flood
Information Estimated highest extend of water is 15.37 mAOD measured in adjacent field

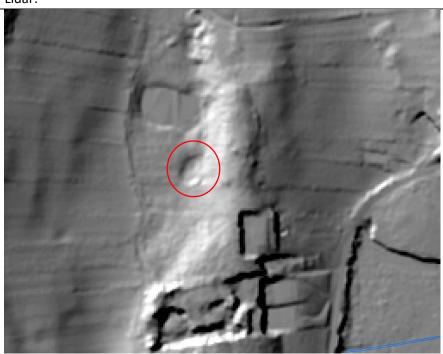
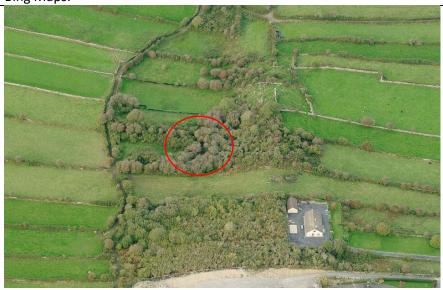
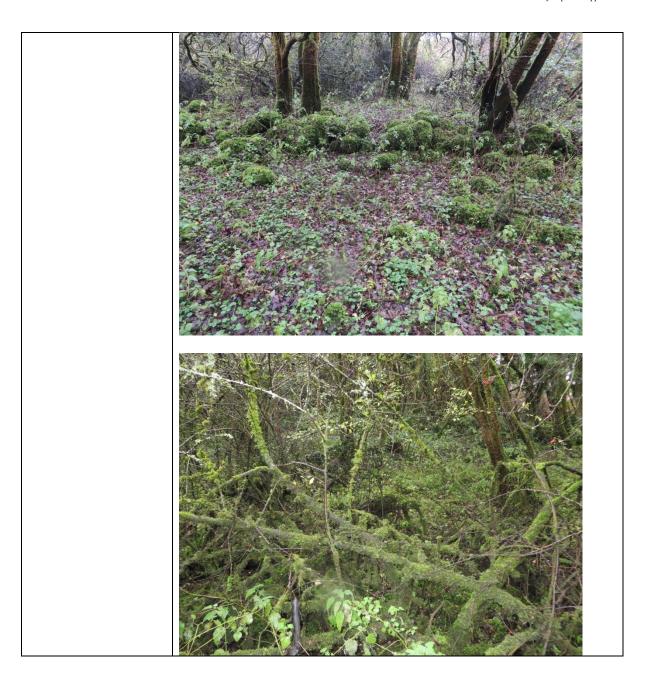
Field survey date	12/11/2014
Field survey status	Confirmed
Water present	No
Ground level	15.46 mAOD, Estimated elevation. Elevation not recorded within feature
elevation	due to tree coverage. Elevation reading taken 20 m south and approx
	1m higher elevation (actual recorded elevation was 16.456)
Additional	Area mossy and covered with trees
Information	
Site photo

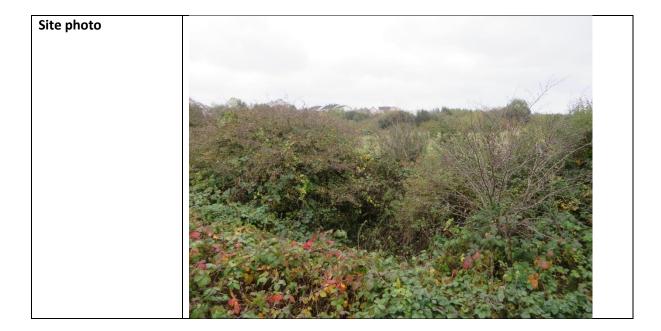
Feature ID	К76
Feature type	Enclosed Depression
Coordinates	531254, 727960
Source	Lidar:
	Bing Maps:
Field survey date	20/10/2014
Field survey status	Confirmed
Water present	No
Additional	10m diameter 4m depth.
- 4	con all all all all all all all all all al

Steep sides with exposed rock

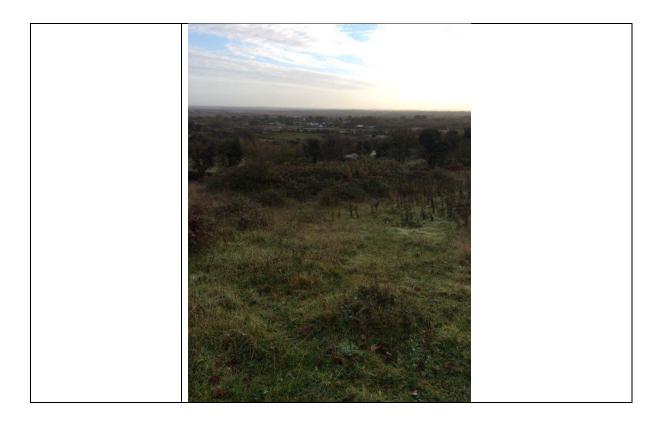
Field survey date	12/11/2014
Field survey status	Confirmation/identification problem
Water present	Unknown
Additional	Could not access very overgrown
Information	
Site photo

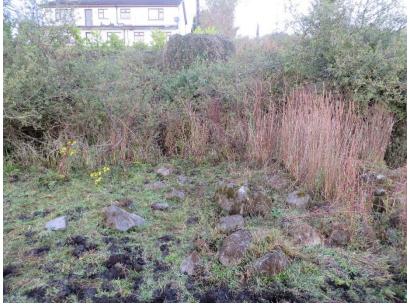
Feature ID	K86		
Feature type	Estavelle		
Coordinates	531476, 729108	531476, 729108	
Source	EIS N6 Galway City Outer Byp	pass Vol 2 2006	
Field survey date	16/10/2014	16/10/2014 11/11/2014	
Field survey status	Confirmed	Confirmed	
Water present	No	Yes	
		Electrical conductivity: 590 uS/cm	
		Temperature: 9 °C	
		pH: 7.52	
		No flow to permit flow measurement	
Water elevation	n/a	8.927	
Additional	Drain runs from estavelle location near break in slope towards		
Information	Ballindooley lough		
Site photo	Estavelle location

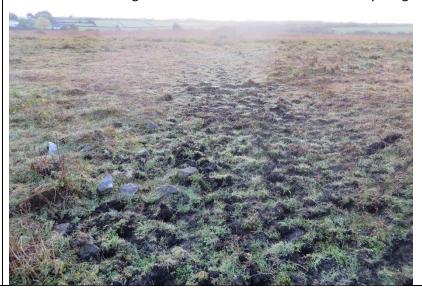
Shallow ditch running between the estavelle and Ballindooley Lough:

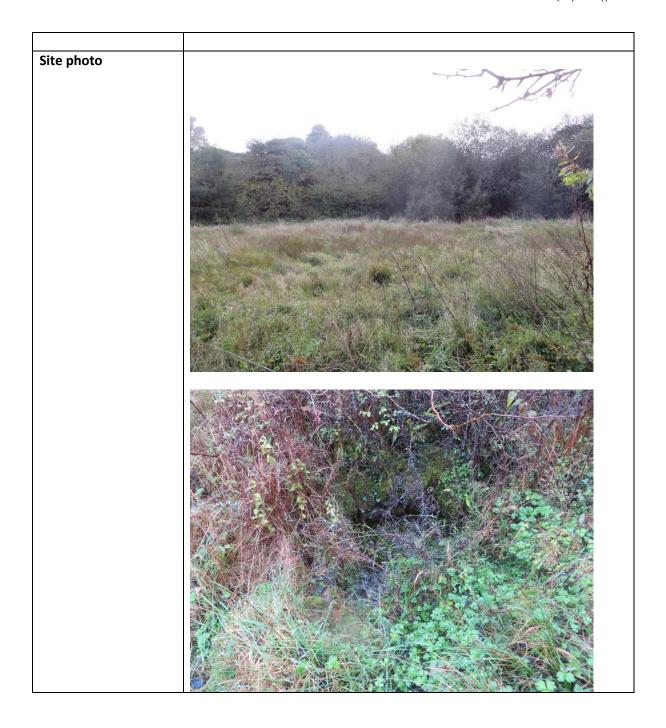
Field survey date	21/10/2014	12/11/2014
Field survey status	Confirmed	Confirmed
Water present	No	Yes
		Electrical conductivity: 219 uS/cm
		Temperature: 8.1 °C
		pH: 6.4
Elevation	n/a	Ground level in centre: 12.11 mAOD
measurements		Standing water: 12.17 mAOD (531947, 728372)
		& 12.22 mAOD (531934, 728379)
Additional	Approx 40 m diameter flat bottom depression. Soft muddy base.	
Information	Sides and base composed of subsoil. No seepages.

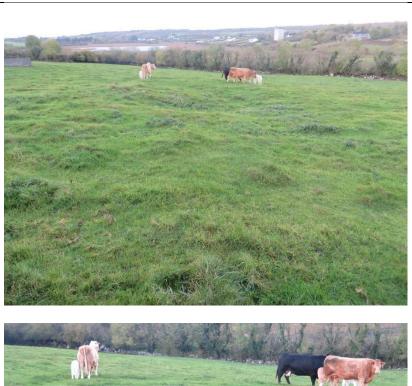
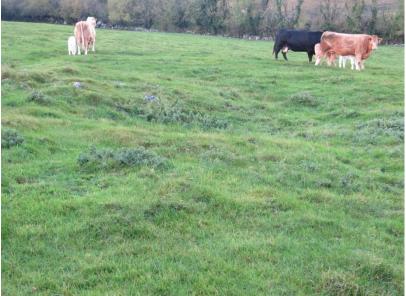
## Site photos

Field survey date	21/10/2014	
Field survey status	Confirmed	
Water present	No	
Additional	Approx. 3m diameter depression	
Information

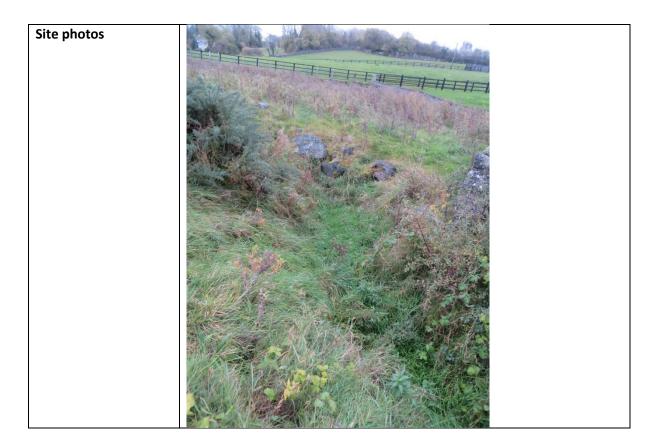
Feature ID	К99	К99	
Feature type	Spring		
Coordinates	531963, 727732	531963, 727732	
Source	531963, 727732 Lidar:		
Field survey date	Bing Maps:  Castlegan Village  21/10/2014  12/11/2014		
Field survey date			
Field survey status		Confirmed	
Water present	No	Yes Electrical conductivity: 995 uS/cm Temperature: 12 °C

Drain leading from spring towards Terryland River

Flow not great enough for flow measurement

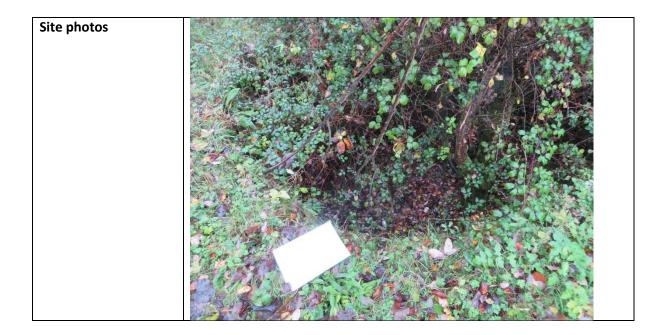
Field survey date	12/11/2014
Field survey status	Confirmed
Water present	No
Ground level	24.01 mAOD at base of depression
elevation	
Additional	Approx. dimensions: 3m diameter, 2m depth.
Information	Very steep sides. Likely to be an old dug well.

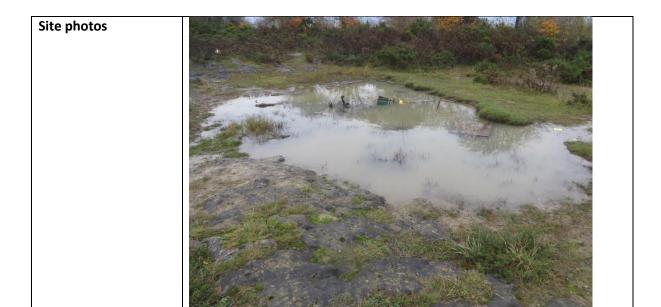
Feature ID	K130
Feature type	Enclosed depression
Coordinates	533711, 726665
Source	Bing maps:
Field survey date	13/11/2014
Field survey status	Confirmed
Water present	Yes
	Electrical conductivity: 199 uS/cm
	Temperature: 7.1 °C
Elevation levels	pH: 8.13
Elevation levels	Base of enclosed depression: 54.74 mAOD Water level elevation: 55.01 mAOD
Additional	
Information	Enclosed depression filled with water from stream k314.
IIIIOIIIIauofi

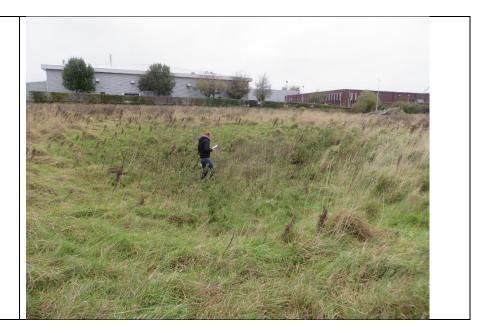
## Site photos

Feature ID	K131
Feature type	Enclosed depression
Coordinates	533815, 728265
Source	Lidar:
	Bing maps:
Field survey date	22/10/2014
Field survey status	
Water present	No
Additional	Approx. dimensions: 10m diameter and 1.5m depth

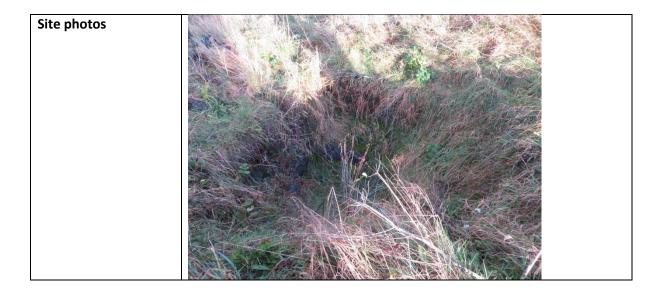
Feature ID	K145
	Enclosed Depression
Coordinates	534209, 724682
Coordinates Source	Enclosed Depression 534209, 724682 Lidar  Bing maps
Field survey date	13/11/2014
Field survey status	Confirmed
Water present	No
Additional	Approx. 2 m in diameter and 1m deep
Information

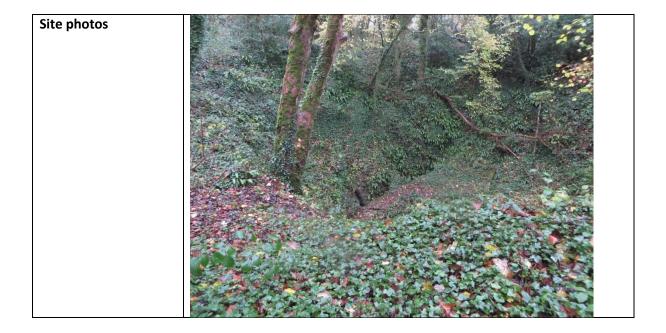
Fasture ID	V4F2
Feature ID	K152
Feature type	Enclosed Depression
Coordinates	534397, 725257
Source	Lidar:
	Bing maps
Field survey date	13/11/2014
Field survey status	Confirmed
Water present	No
Additional Information	Approx. 7m diameter. Adjacent to K151

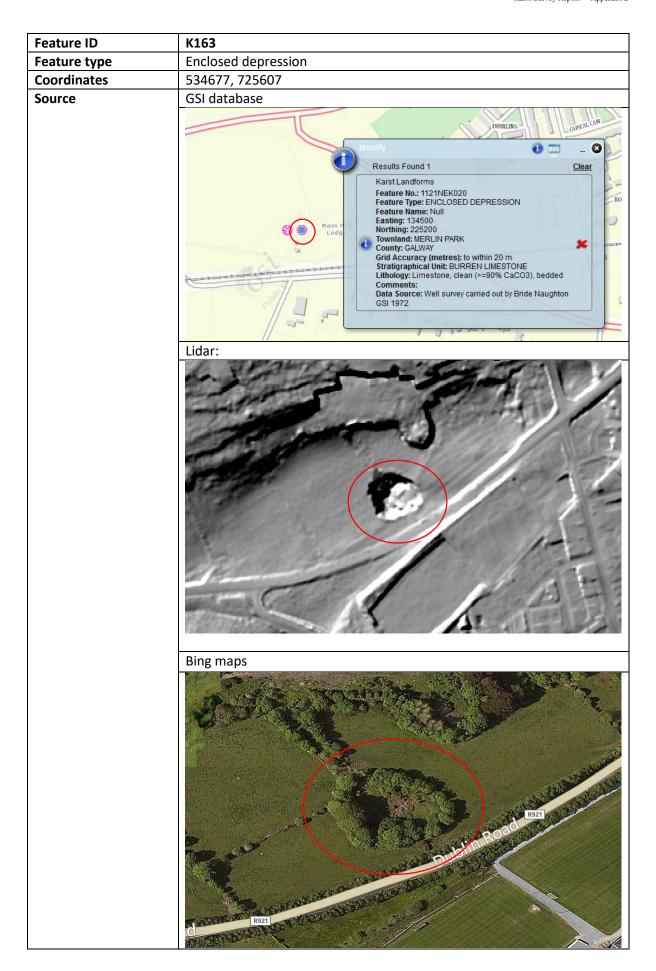
Field survey date	14/11/2014
Field survey status	Confirmed
Water present	No
Ground level	Elevation within depression 13.39 mAOD. This is not the base of the
elevation	depression
Additional	Very large depression.
Information	Large part of enclosed depression is filled in with waste and material.
Site photos

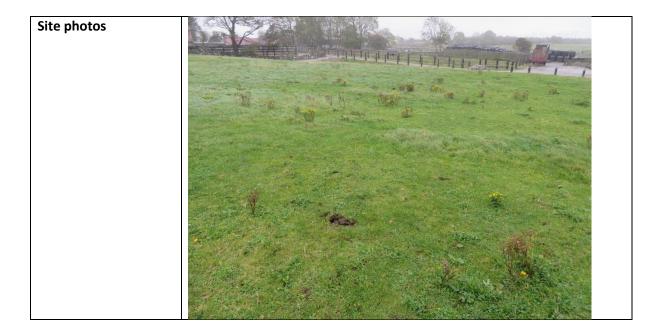
Feature ID	K172
Feature type	Enclosed depression
Coordinates	534791, 727078
Source	Lidar:
	Bing maps  The state of the sta
Field survey date	23/10/2014
Field survey status	Confirmed
Water present	No
Additional	Very shallow depression
Information

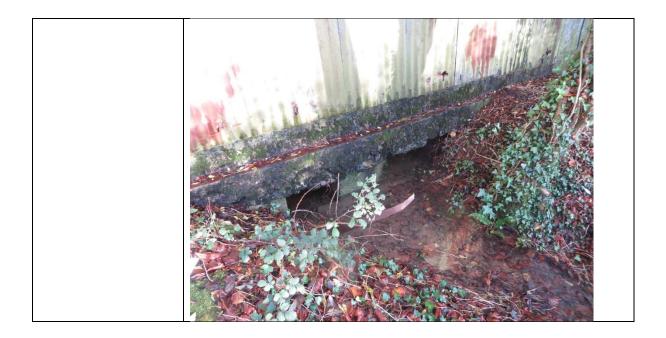
Feature ID	K173
Feature type	Spring
Coordinates	534843, 725787
Source	GSI Database: Well survey carried out by Bride Naughton GSI 1972.
	Results Found 1  Clear  Karst Landforms Feature No.: 1121NEK024 Feature Type: SPRING Feature Name: Null Easting: 134900 Northing: 225750 Townland: DOUGHISKA County: GALWAY Grid Accuracy (metres): to within 20 m Stratigraphical Unit: BURREN LIMESTONE Lithology: Limestone, clean (>=90% CaCO3), bedded Comments: Data Source: Well survey carried out by Bride Naughton GSI 1972.
Field survey date	14/11/2014
Field survey status	Confirmed
Water present	Yes Electrical conductivity: 510 uS/cm Temperature: 9.7 °C pH: 7.88 Flow: 6.3 l/s
Water level elevation	25.22 mAOD
Additional	Spring discharges from under an old building.
Information	Spring and an area are are a same and
Site photos

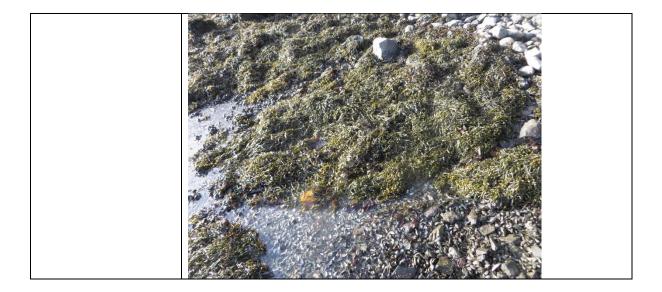
Feature ID	K182
Feature type	Spring
Coordinates	535092.48, 724857.76
Source	OSI Historic 6" Map
Field survey date	14/11/2014
Field survey status	Confirmed
Water present	Yes
	Electrical conductivity: Outside instrument range Temperature: 11.5 °C pH: 7.34
Additional	Flow from spring too wide to measure. Flow discharges directly to sea
Information	
Site photos

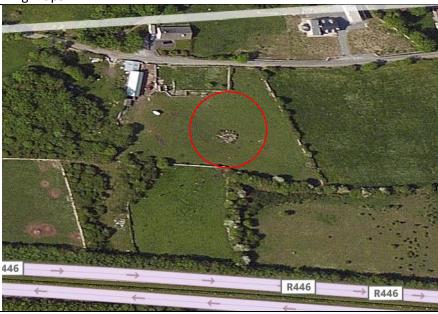
Feature ID	K198
Feature type	Enclosed depression
Coordinates	535953, 725945
Source	GSI database: Well survey carried out by Bride Naughton GSI 1972.

Field survey date	18/11/2014
Field survey status	Confirmed
Water present	Yes
	No water quality analysis recorded
Additional	Farmer noted that the depression fills with water
Information	
Site photos

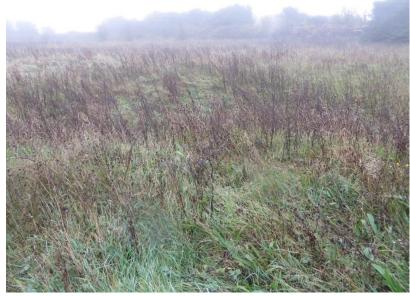
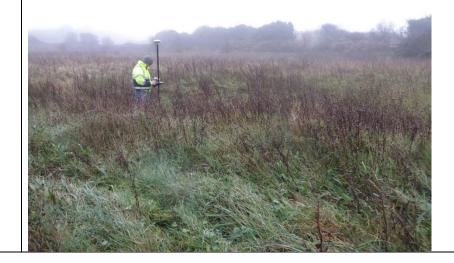
Feature ID	K203
Feature type	Enclosed depression
Coordinates	536033, 725740
Source	Field survey
Field survey date	18/11/2014
Field survey status	Confirmed
Water present	No
Ground level	29.44 mAOD
elevation	
Additional	Small enclosed depression
Information	Approximate dimensions: 5m x 2 m less than 1 m deep
Site photos

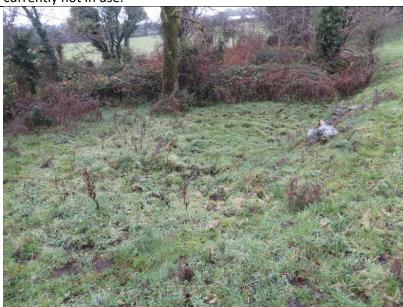
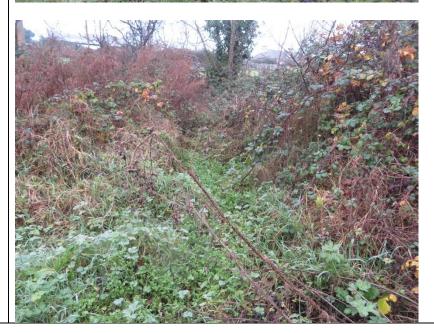
## Site photos

Feature ID	K210
Feature type	Spring
Coordinates	536114, 725968
Source	Results Found 1  Karst Landforms Feature No.: 1121NEK023 Feature Type: SPRING Feature Name: POLLBEG Easting: 135980 Northing: 225900 Townland: ARDAUN County: GALWAY Grid Accuracy (metres): to within 20 m Stratugraphical unit: BURREN LIMESTONE Lithloogy: Limestone, clean (>= 90% CaCO3), bedded Comments: Data Source: Well survey carried out by Bride Naughton of the GSI 1972.
	Lidar:
Field survey date	18/11/2014
Field survey status	Confirmed
Water present	Yes Electrical conductivity: 704 uS/cm Temperature: 9.8 °C pH: 7.88
Water level elevation	26.37 mAOD
Additional	The spring is at the base of a depression. The ground is very soft and
Information	covered in vegetation. Water is present, however due to the low water

The landowner lives in the house across the road and informed us that the spring has been used in the past as the drinking water supply but is currently not in use.
